**RE: Inspection Notice: Mill Dam, D155030, Non-Menace Hazard Potential, Meredith**

D155030, Mill Dam, Meredith: Inspected December 14, 2020

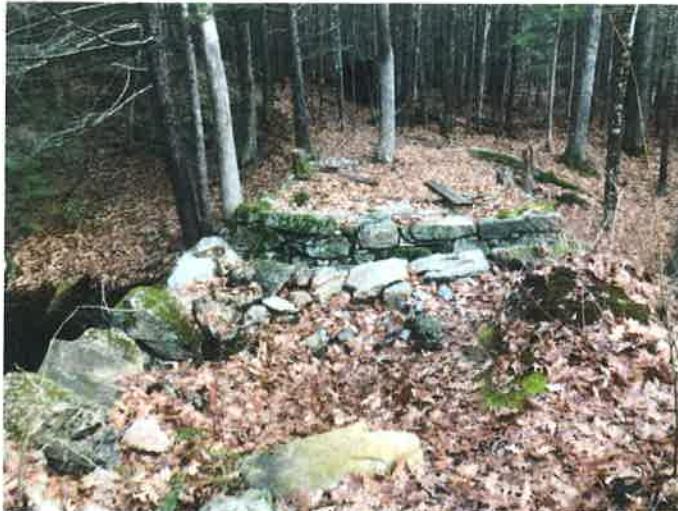
IMG\_3968

- a. Leakage on the order of 100 gallons per minute observed along the lower portion of the spillway (Photo 3977); and
  - b. Settlement/sink-hole observed on the left abutment adjacent to the training wall. Potentially resultant of water movement through the dam; however, there is a raised area adjacent, so it could be resultant of excavation (Photo 3968).

- a. Multiple large/mature trees located on and adjacent to the dam.
4. Sinkholes were observed on the dam (see location notes below) and a significant quantity of leakage through and adjacent to the spillway section. Fill the sinkholes with a low-permeability granular soil, similar to the embankment soil material, and evaluate a plan to monitor, record, and evaluate the presence of sinkholes on the dam. Often the presence of sinkholes can be attributed to leakage/seepage through the dam and/or the transportation of sediment through the dam via a preferential pathway. It is recommended that leakage and sinkhole observations are made concurrently. Observations from the 2020 inspection as follows:

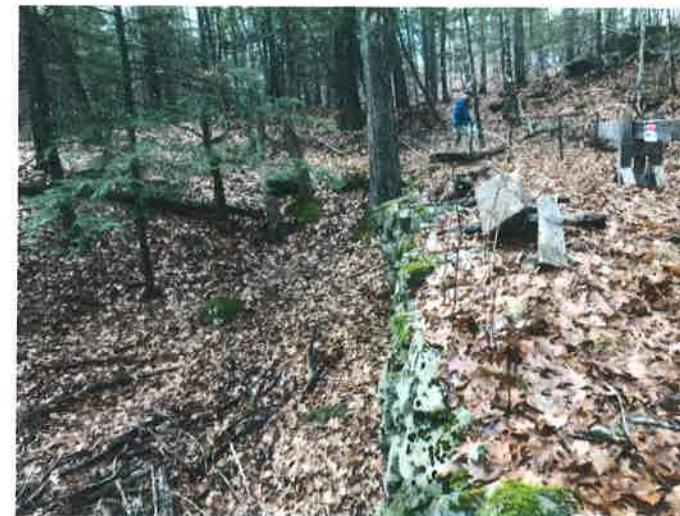
IMG\_3970

5. Continue to monitor and evaluate the masonry portions of the dam and complete maintenance as required.
  - a. Masonry portions of the wall appeared stable. Some minor bulging observed along the right abutment (Photos 3970 and 3975).
